Analysis Report

Denver VII

Customer SIEMENS NA

Project-Part Doors

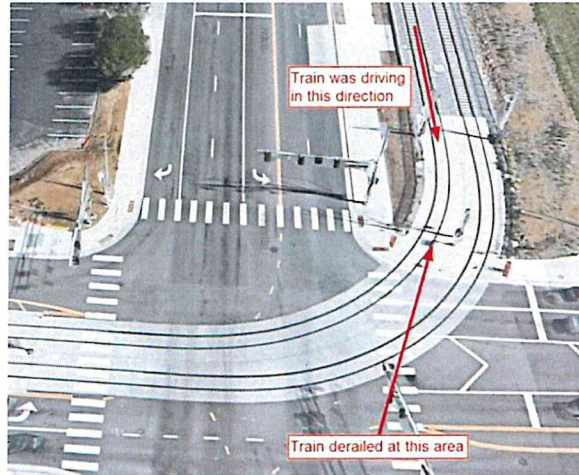
Image 5: Accident location

4.3 Accident description

The front car (B car) was caught in the rails of the counter direction; the end car (A car) was sliding
 Copyright © Knorr-Bremse AG. All rights reserved, including industrial property rights applications. form sheet: N402500R80-00
 Knorr-Bremse AG retains any power of disposal, such as copying and transferring.

over the rails. During the derailment the train tipped on an angle and was sliding only on its outer wheels (train side of Door 1) and all lower door portal structure on this side.

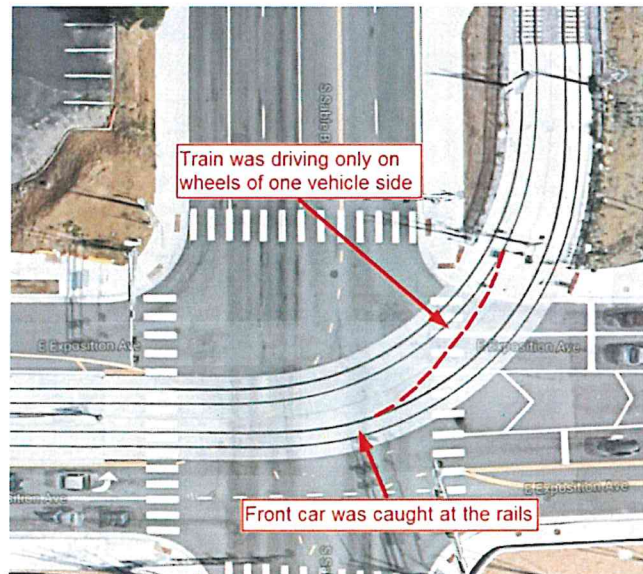
Image 6: Sliding traces during first impact

It can be assumed that there were two significant impacts to Door 1. The first impact was the collision of the door leaf with the threshold (see Image 18: Threshold with mark of door leaf) caused by the derailment of the train. Due to the derailment and tilting of the train a passenger was forced down, impacting the door leaf.

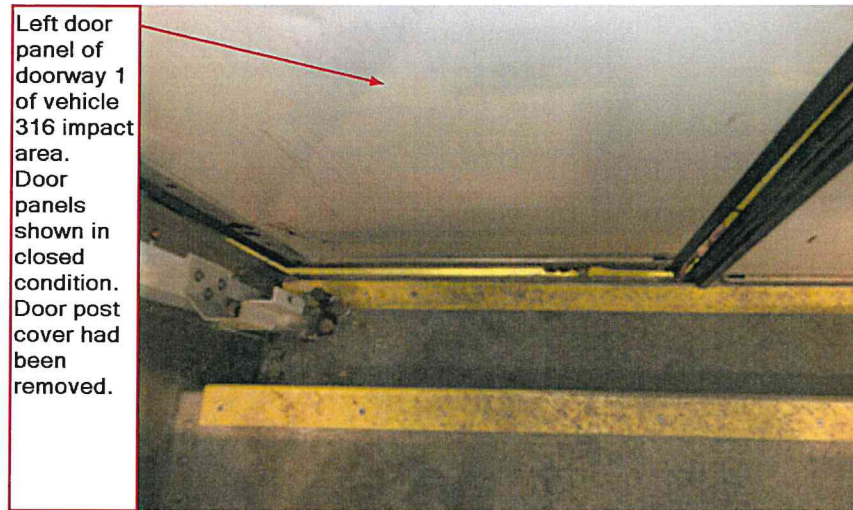
Image 7: Stairs at door 1

Due to the above described consequences of the accident a part of the passenger's leg was exposed outside of the train, got trapped between threshold and street and was severed. When the leg was trapped between threshold and street the passenger was pulled out of the train through the gap between threshold and the left door leaf (view from inside; see also Image 7)

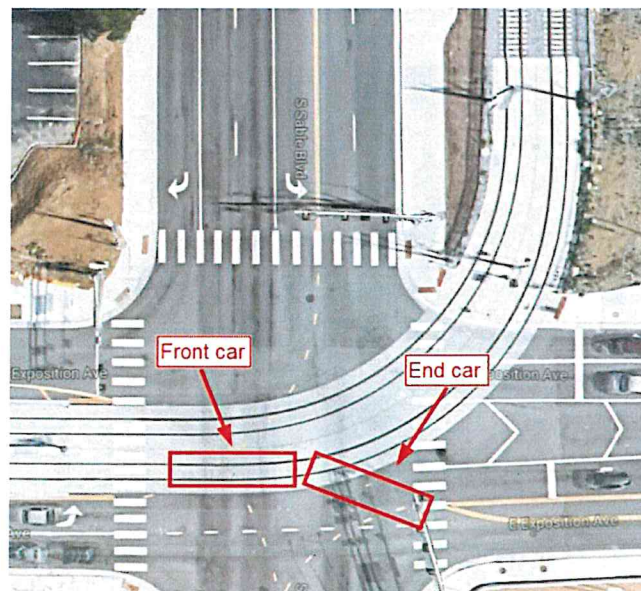
Image 8: A-CAR sliding over rails

There was a second impact on Door 1 which is assumed to happen when the end car was sliding over the rails. The lower member of the door portal was bent to the inside of the vehicle during this impact it had direct contact with the street.

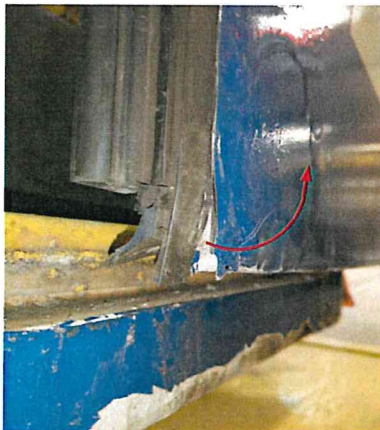
Image 10: Threshold - Lower door leaf

- The right door leaf of Door 1 rotated counter clockwise (view from outside) and pushed the support roller to the end of the elongated holes

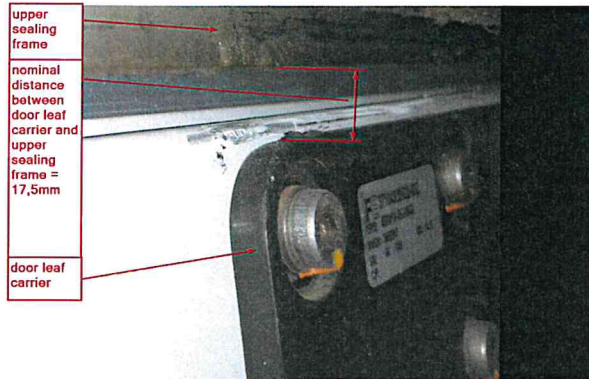
- Door leaf and door leaf carrier were twisted and collided with the upper sealing frame

Image 12: Scratches on door leaf and carrier

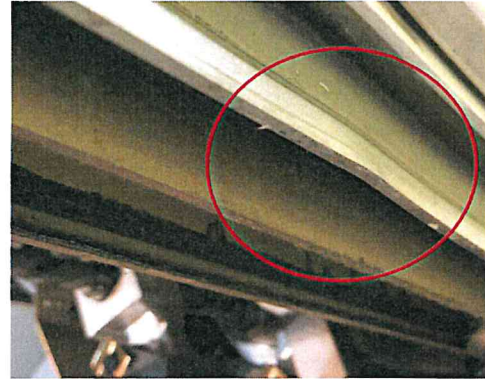
Image 13: Bending on sealing frame

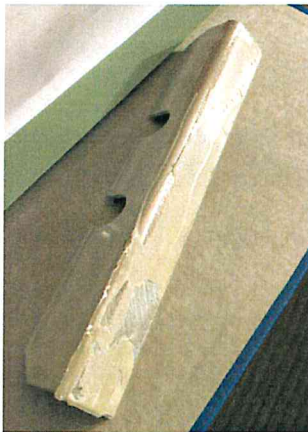
- Lower bracket (kick out protection which is installed to prevent vandalism by passengers) was ripped off by the roller swing arm

Image 14: kick out protection

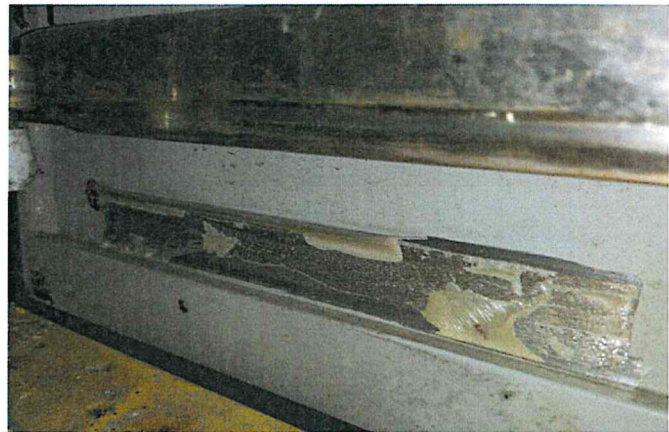
Image 15: Bonding area of kick out protection on left door leaf of doorway #1 vehicle 316

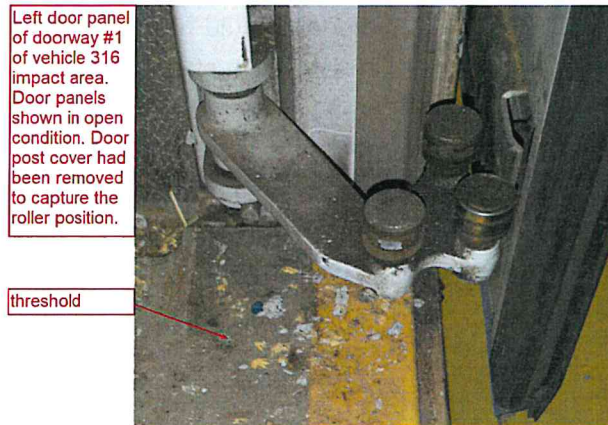
- The door leaf was lifted out from the roller swing arm and therefore had no guiding in the lower area anymore.

Image 16:
Lifted out roller swing arm

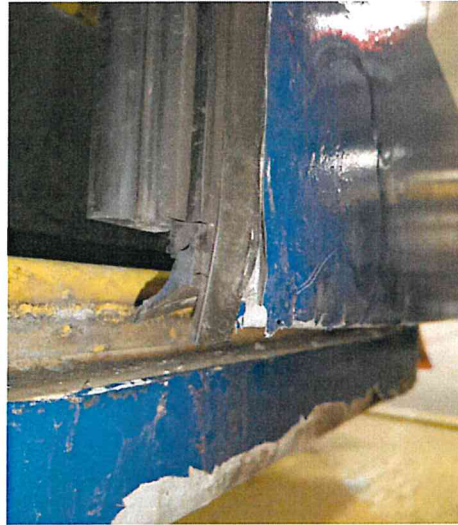
- Door leaf guiding rail did not show any indication of movement due to the accident
- Even though the paint of the door leaf was cracked under the left door leaf carrier and at the pressure plate (see image 11) there was no deformations visible (flexible bending)
- The lower left door leaf area showed plastic deformation because of the collision with street

Image 17: Plastic deformation on left door leaf

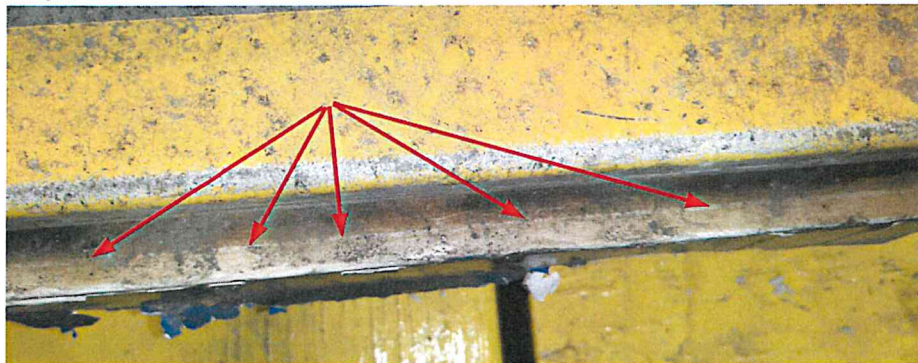
- Door panels were in contact with the lower member of the door portal during the first impact of derailment

Image 18: Lower member of the door portal with mark of door leaf

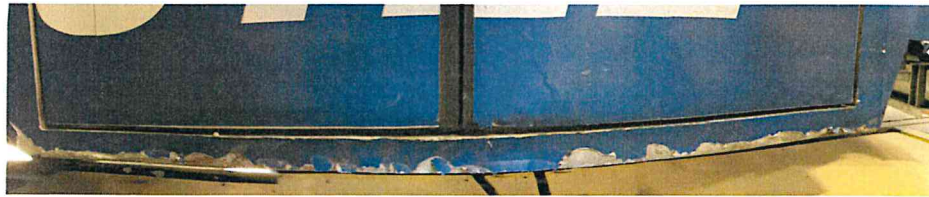
Image 19: Threshold Door 1

- All thresholds on the left side of the train made contact with the street and rails, most of the weld seams on the lower side of the thresholds were broken.

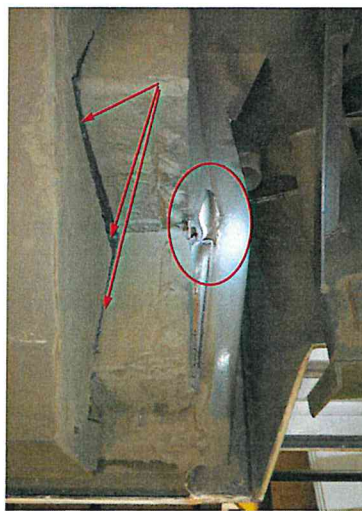
Image 20: Right portal side of threshold doorway #4- broken welding seams

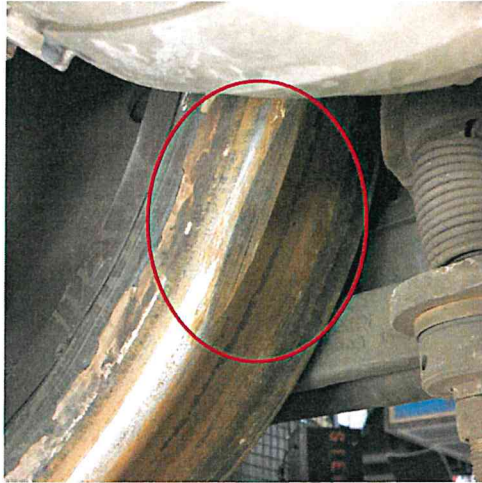
- The second wheel on the front wheel has a flat spot due to sliding over the street

Image 21: Flat spot on wheel

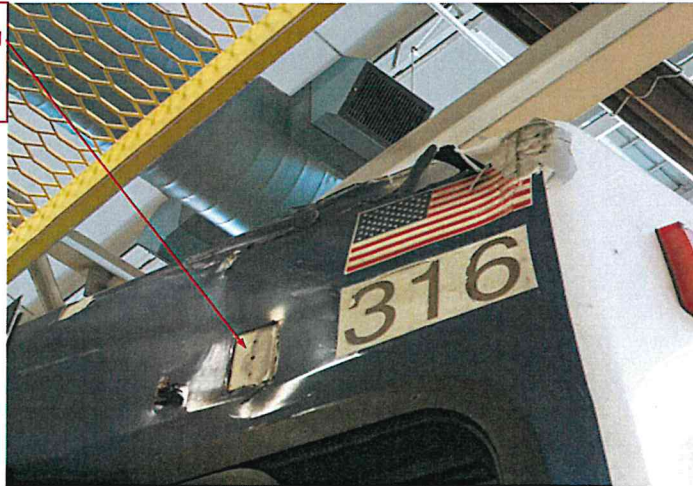
- Damage on the top of the end car due to collision with the light pole.

Rear view
mirror ripped
off during
collision with
the pole.

Image 22: Top of end car

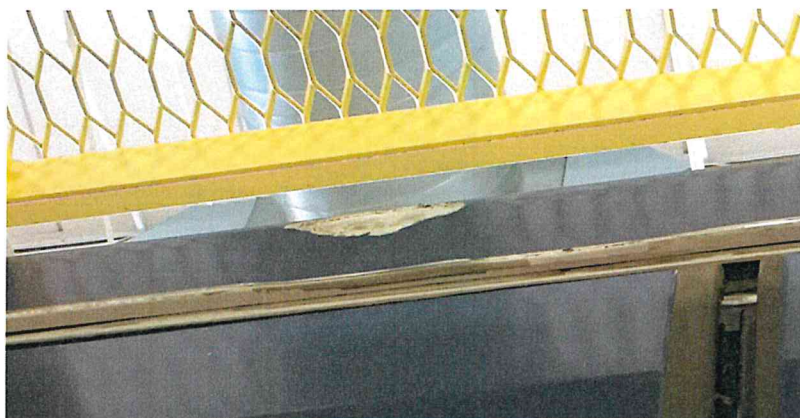
- Damage of the car body and rain water gutter above Door 1

Image 23: Scratch above Door 1

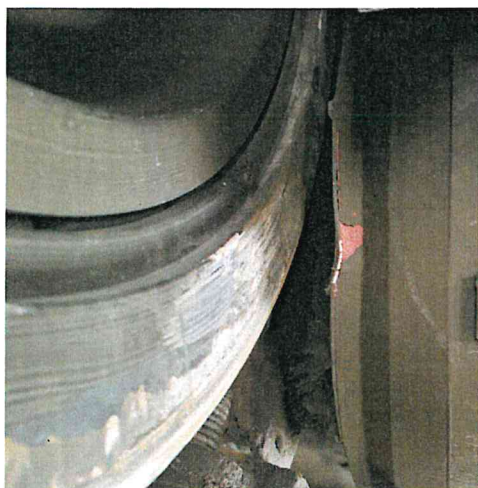
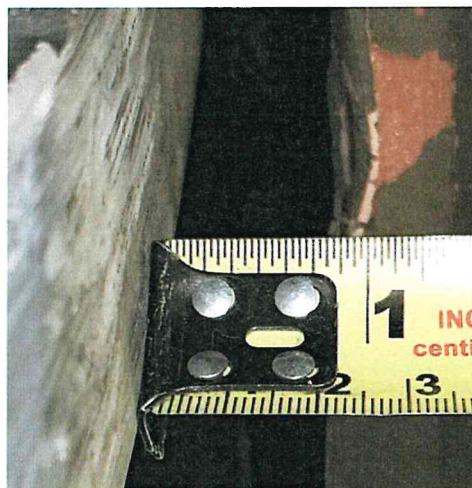
- Collision of end bogie with underframe structure

Image 24: Damage on tank

Image 25: Measurement traction motor
