Analysis Report

Denver VII

Customer SIEMENS NA

Project-Part Doors

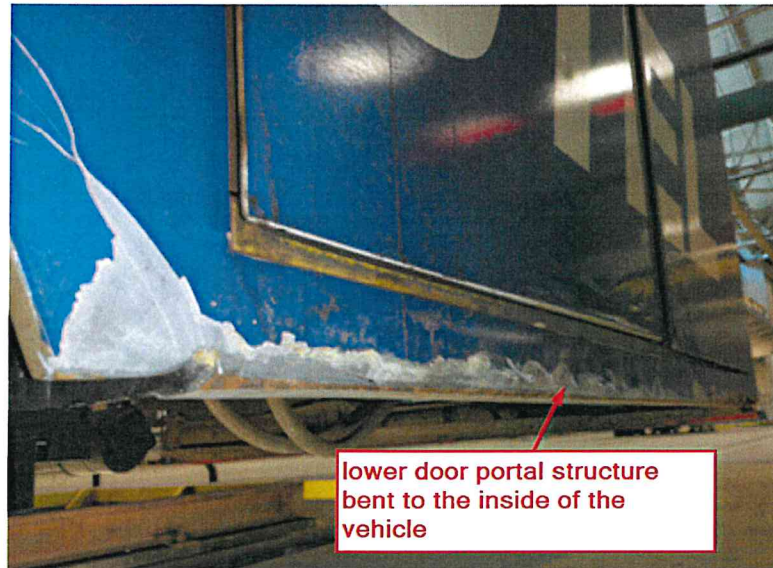
Image 9: Threshold of door 1

There was a second impact on Door 1 which is assumed to happen when the end car was sliding over the rails. The lower member of the door portal was bent to the inside of the vehicle during this impact it had direct contact with the street.

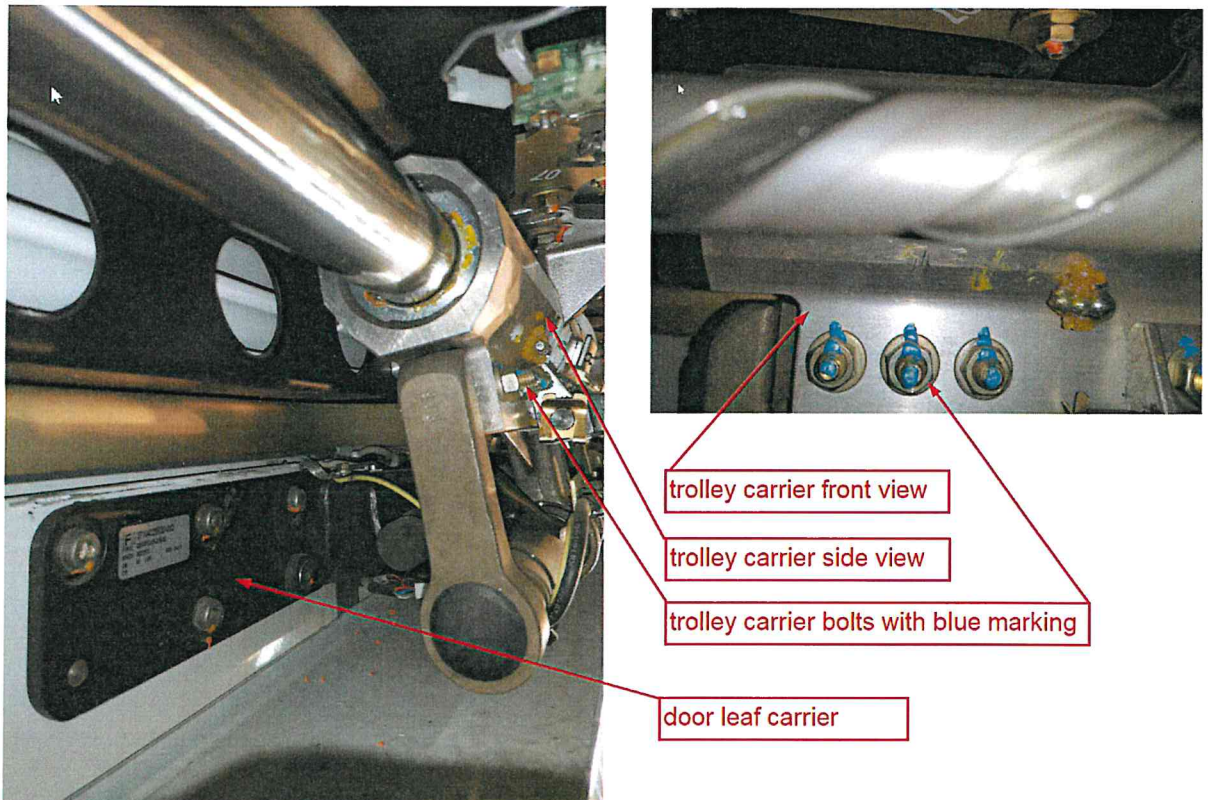
- No plastic deformation of the portal could be measured. (height, diagonal measurement)
- All mounting bolts of the drive unit were still in position (screw marking not cracked), only the marking of the left door leaf mounting bolts was cracked.
- Bolt markings on the trolley carrier were not cracked

- Door leaf guiding rail did not show any indication of movement due to the accident
- Even though the paint of the door leaf was cracked under the left door leaf carrier and at the pressure plate (see image 11) there was no deformations visible (flexible bending)
- The lower left door leaf area showed plastic deformation because of the collision with street
